# TSUNAMI IMPACTS IN THE REPUBLIC OF SEYCHELLES, WESTERN INDIAN OCEAN

## ABSTRACT

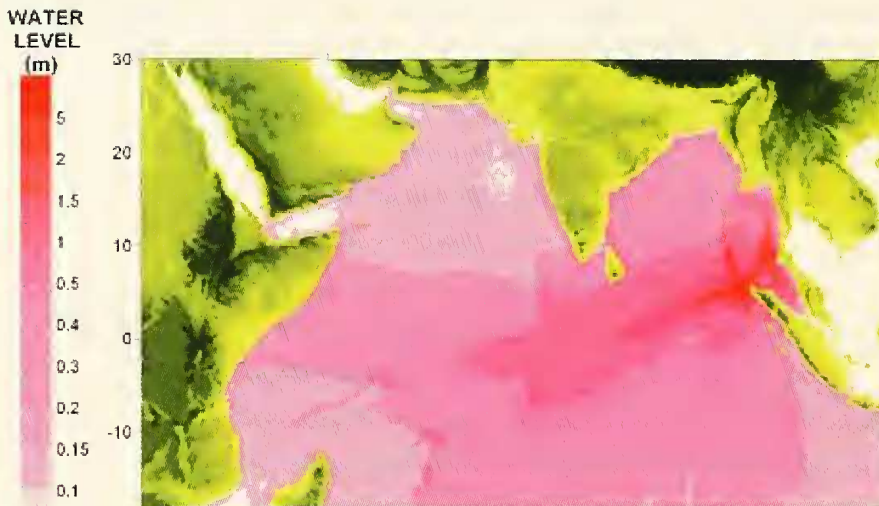
**Figure 3.** Computer modelling of the 26 December, 2004 tsunami after 900 minutes (courtesy of A. Yalciner, U. Kuran, T. Taymaz) (available at: <http://yalciner.ce.metu.edu.tr/sumatra/max-elev-sim-1.jpg>).

Tsunami amplitudes are greatest perpendicular to generating structures; thus the NNW–SSE orientation of the earthquake faultline between NW Sumatra and the Andaman Islands put the Seychelles Bank directly in line with the tsunami wave front as a simulation of wave heights 15 hours after the earthquake makes clear (Fig. 3; Yalciner et al., 2005).

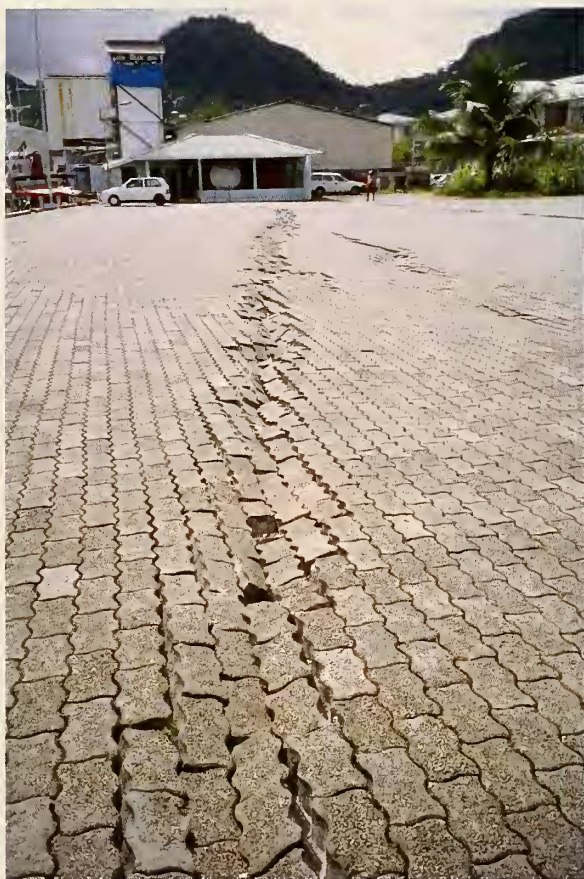
**Plate 1**

Plate 1. Internal fissuring and collapse of dock quay, Port Victoria, Mahé.

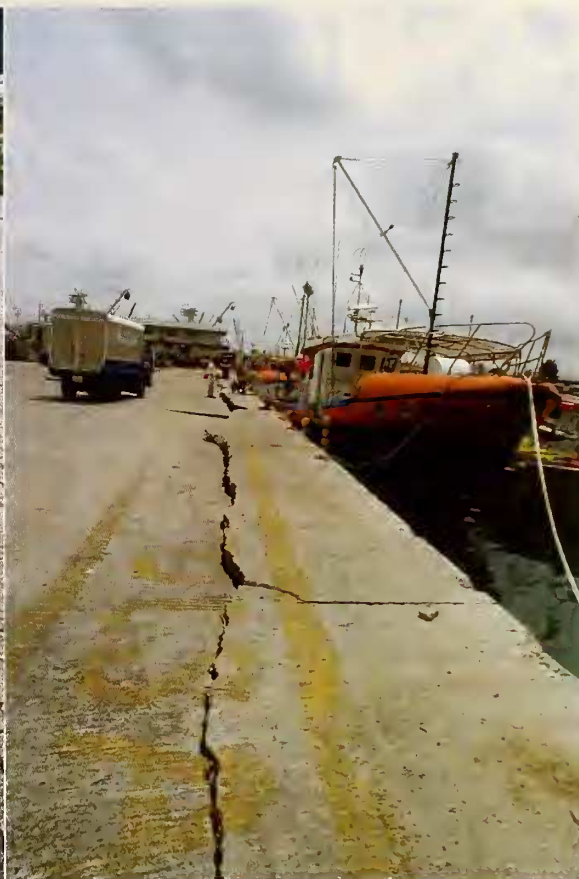
**Plate 2**

Plate 2. Failure of quayside, Port Victoria, Mahé.

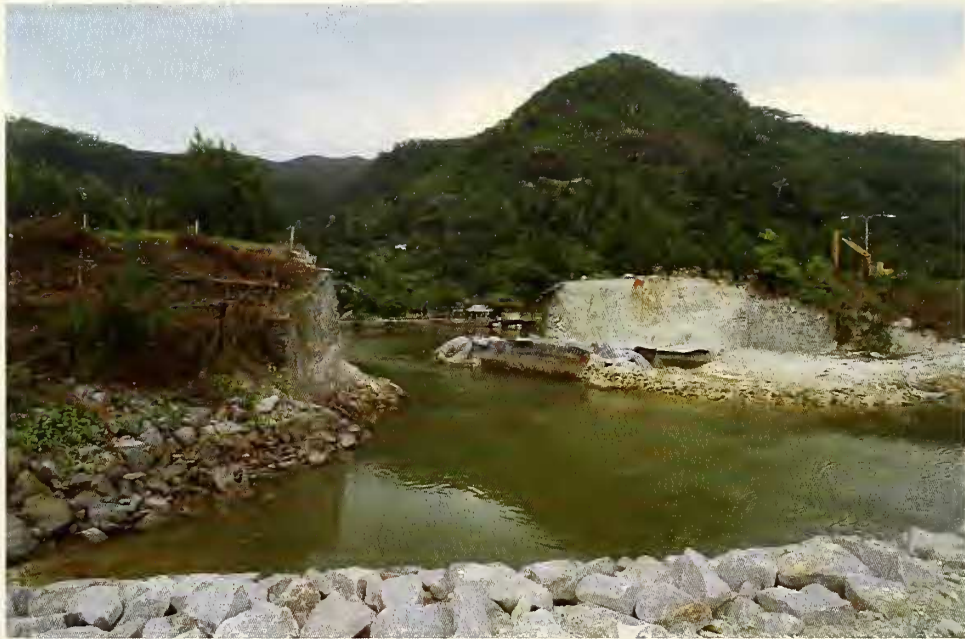
industry, and rapid road access to the airport, typically is separated from the old island shoreline by open water. Surges in sea-level can thus be ponded behind them and can only drain back to sea via egress channels. This accounts for the destruction of the bridge shown in Plate 3. Drawdown and upsurge were also severely damped in the lee of the reclamations.

**Plate 3.** Road bridge washout from seaward drainage of tsunami waters from coastal lagoon, west coast of Mahé.

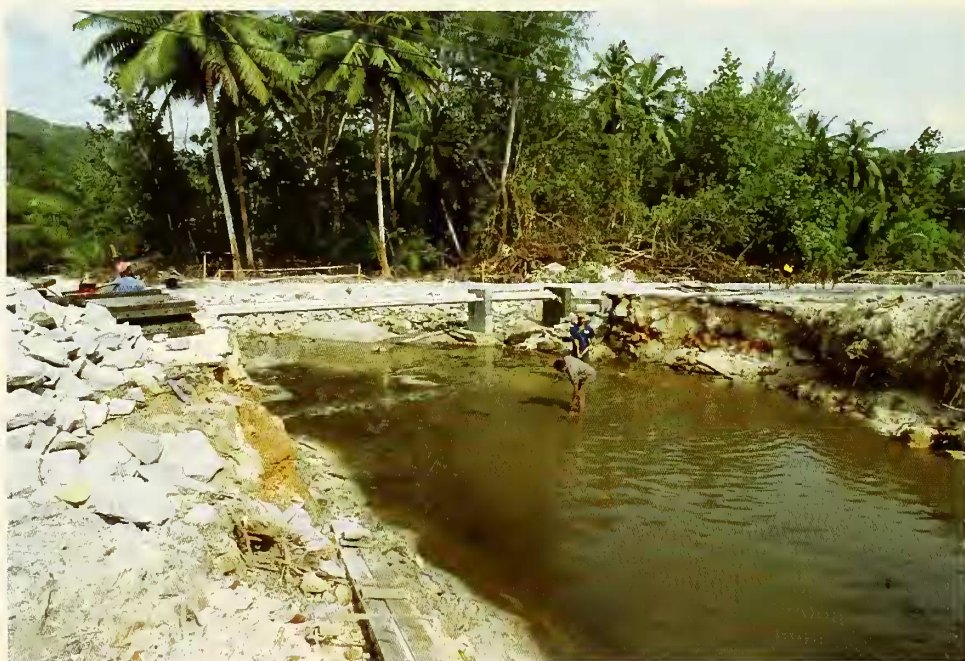
**Plate 4.** Road bridge washout following drainage of tsunami waters, southwest Mahé.
